the origins and treatment of derelict land in county Durham

The origins and treatment of derelict land in County Durham

**The University of Durham
Department of Geological Sciences
January 1998**

This thesis is submitted in partial fulfilment of the requirements for the
degree of M.Sc. in Environmental Management Practice

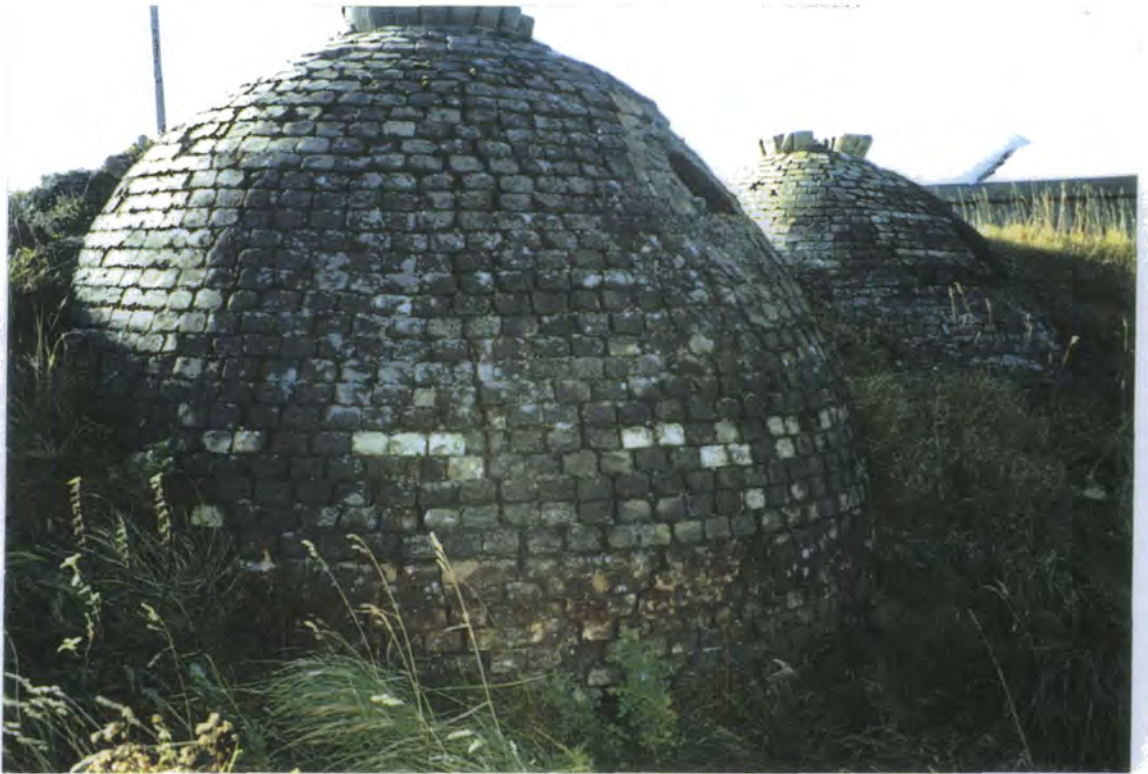
Figure 13.2

It is reasonable to deduce from the age of many of these collieries as shown in mine records or on early O.S. maps, putting them before the end of the 19th. century, that the ovens must have been simple beehive construction and therefore of less concern than those with by-product recovery.

Beehive Oven

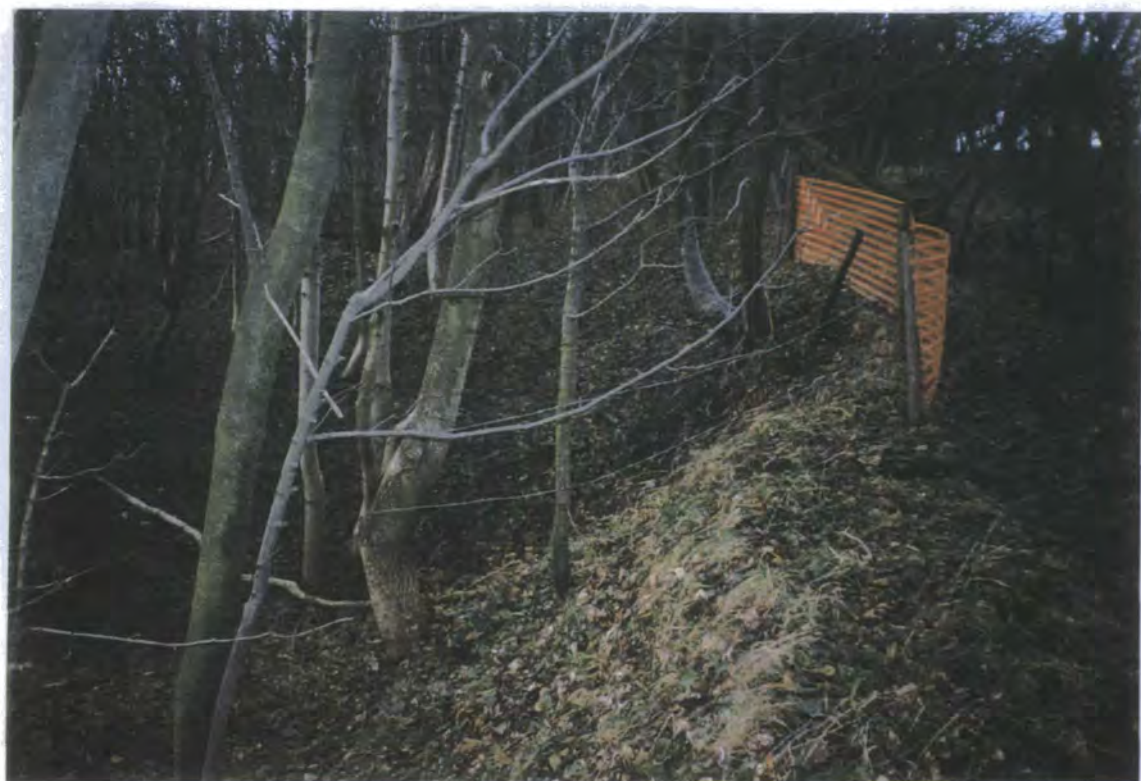
Figure 17.1 Coal Shaft - Footpath

(a) O.S. Sheet 33 was selected in the western area which, although containing many old abandoned mines, had also been heavily opencasted, resulting in far fewer sites potentially requiring remedial works. Initial screening by name alone suggested 15 mines or groups which appeared to be worth further examination and closer inspection of old O.S. maps revealed that these contained in all 37 features (Appendix 3). From a primarily visual point of view only one site was included in the local authority's schedules and this was classified as not justifying reclamation. Two other sites however, identified in this review, are in close proximity to housing and public access routes and should be considered for treatment, even under the original policy. In none of the cases could stability of the heaps be seen as a major problem. From a safety point of view, taking into account the other potential dangers posed by old mine workings, risk clearly relates to the presence of a receptor, and this is then dependent on the proximity of buildings or on public access being available. Of the 37 shafts and drifts identified only one could be clearly thought of as being a risk and this has obviously been realised by the local authority with safeguards being put in place (Figure 17.1).

Remedial works or a footpath diversion will ultimately be required. Although other examples are present of shafts in quite close proximity to footpaths, these routes are little used and can be considered as low risk. The farming community is generally very efficient in monitoring the condition of their land and it is likely that any movement or danger will become apparent to them before the general public. Given the guidance in Table A of the governments consultation document that only a 10% loss should be considered significant in respect of stock, the risk relating to those sites in ordinary agricultural locations has to be put as low (Figure 17.2).

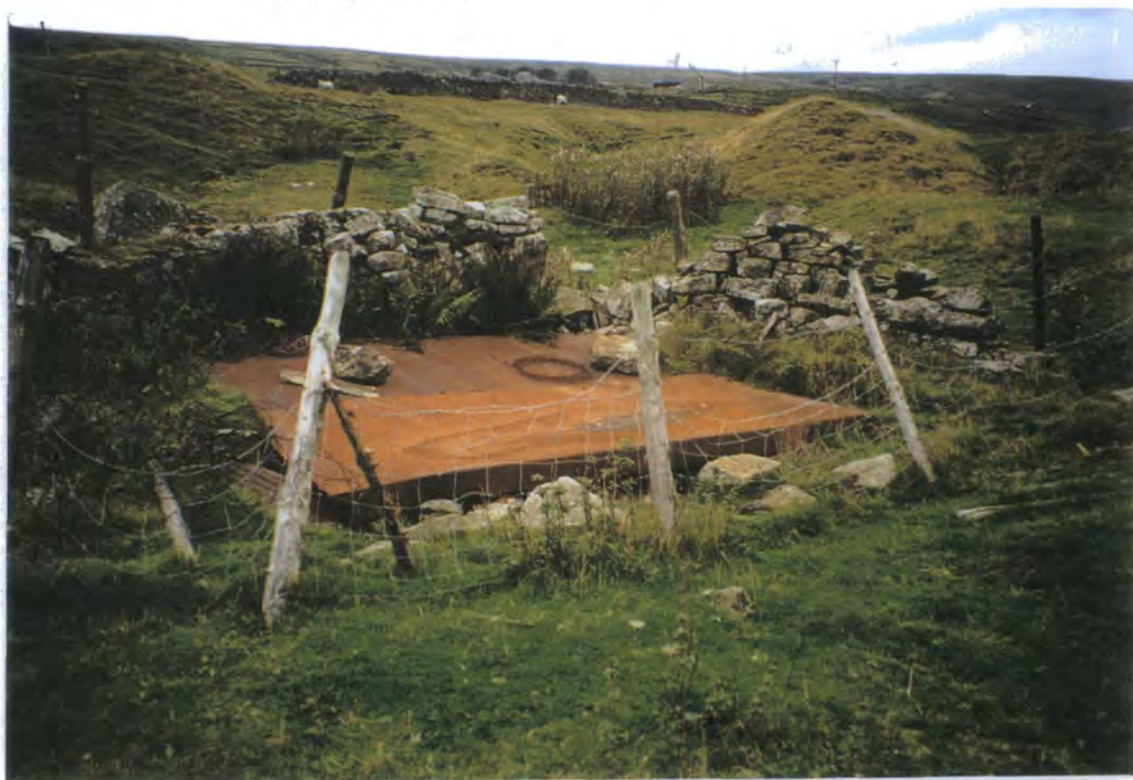
Figure 17.3

on a moorland area is equally unlikely. One level of the remaining four sites is in a works area and not easily approached (Site 5c) and a reopened lead mine is also in private property. The shaft and drift remaining have differing degrees of risk attached to them, based on the probability of access, which was reviewed in the light of weighting relating to frequency of use of the public rights of way in the area, provided by local authority staff closely concerned with countryside and leisure matters. An exercise carried out as part of this study demonstrated that classification of footpaths by usage is a quick and simple exercise and can provide a means of refining the risk potential of derelict sites. The shaft (Site 2a) although clearly visible and with only a poor fence protecting a loosely fitting metal cover, is not a high risk despite it being situated only some 40 metres from a footpath as the route is classified as having the lowest level of usage (Figure 17.3).

Iron Mine - Cover

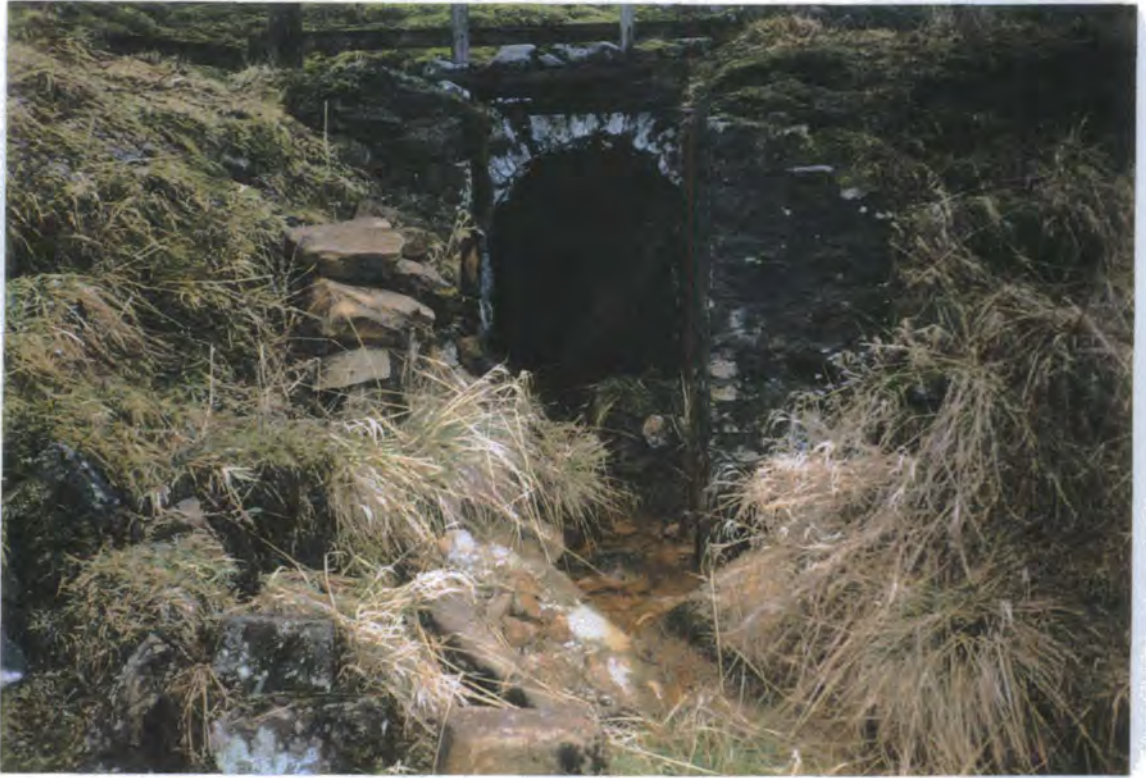
Figure 17.4 Drift Entrance - Iron

The drift on the south east bank of the river (Site 5a) is not a high risk with the entrance clearly visible but it does lie on a footpath designated as having the highest local use. The mine water issuing is clearly polluted with evidence of staining (Figure 17.4).

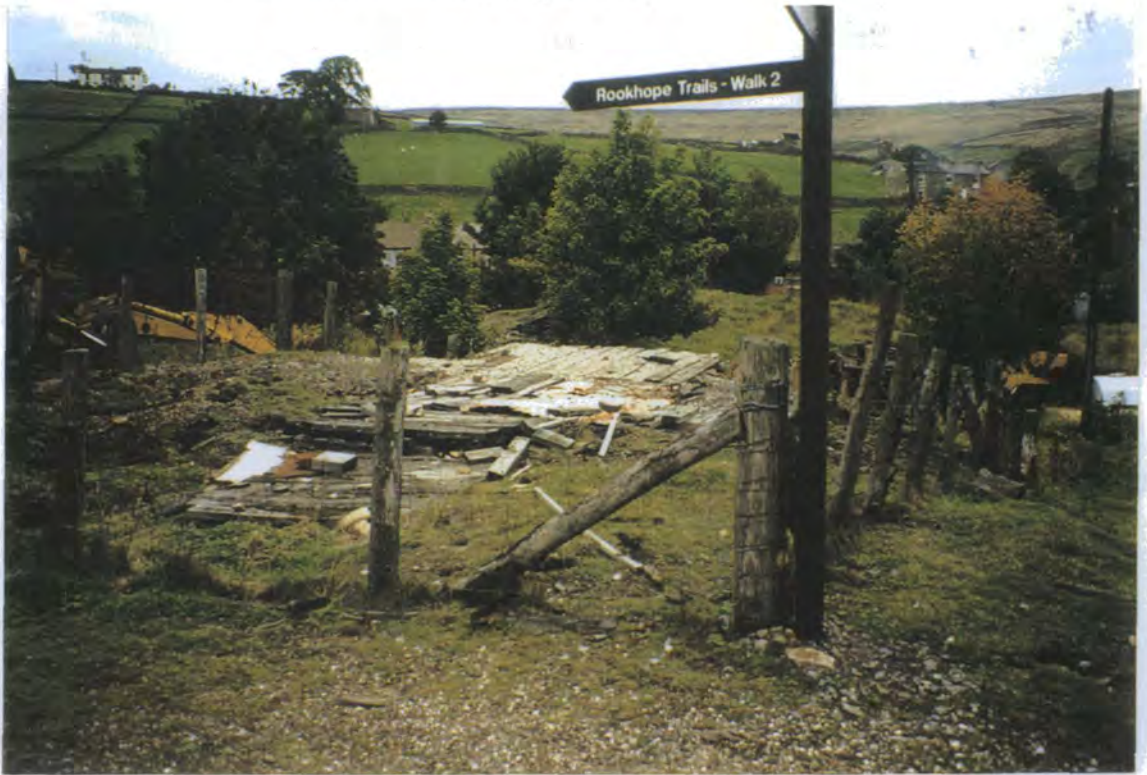
Figure 17.5 Lead/Iron Shaft

Examination of the site also produced a clear example of the problems which can exist in such a complex mining area. In the vicinity of the drift is an engine house shaft which, although almost on the line of the Red Vein, was in fact the main access to Watt's Level serving the Boltsburn East Mine on the north east side of the valley, which was primarily worked for lead. As reserves in the vein were not exhausted when the deep workings were allowed to flood in 1932, consideration was given to reopening the mine and this led to Watt's Level being kept pumped out until the 1950's (Dunham, 1990). The shaft was

apparently filled, but the quality of the work is unknown, and there is only a poor quality fence to deter access to the 54 metre deep shaft and its inadequate timber cover which vandals have attempted to burn. The shaft is immediately adjacent to the 'Rookhope Trail' which has a top classification in terms of usage and there must therefore be a reasonably high degree of risk attached to this site (Figure 17.5).

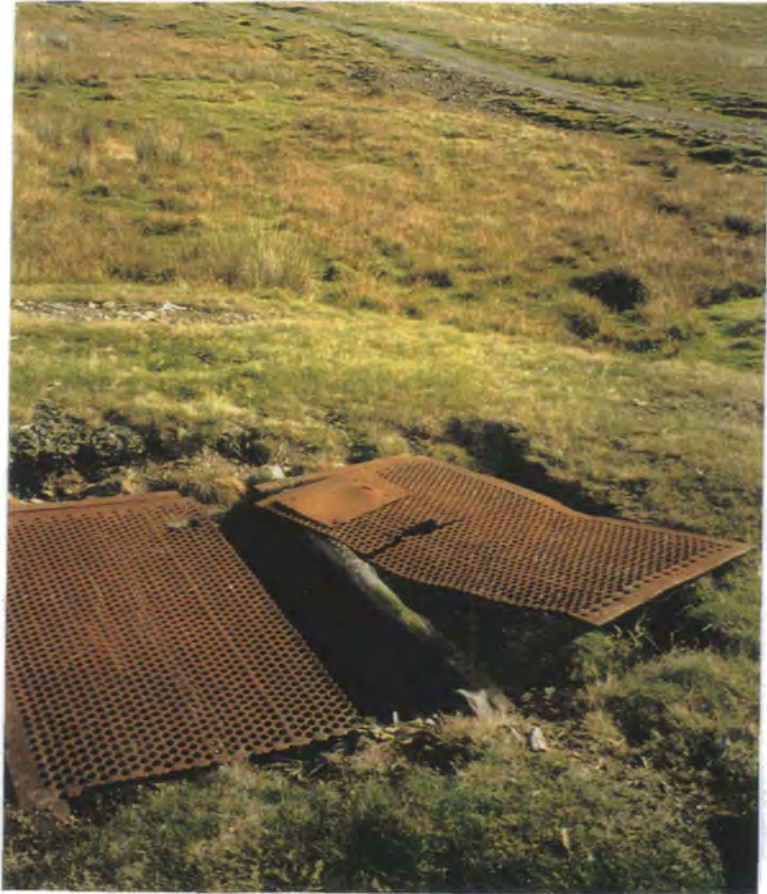
Figure 17.6 Lead Shaft

examined (18) where a level is quoted in mine records but nothing is shown on O.S. sheets other than sink holes in the vicinity. Although there is evidence of ground disturbance on site, no clear entrance can be seen in what appears as a large mound on the verge of a minor road. The last category is that of levels or shafts shown on the O.S. sheets but not identified in mine records. Two sites were looked at (NY9245-2778, NY9583-2963), in both cases being close to footpaths. Circumstances differed on site with the former shaft only visible as a depression in a field whilst the latter site had an open shaft only loosely protected by a metal sheet (Figure 17.6).

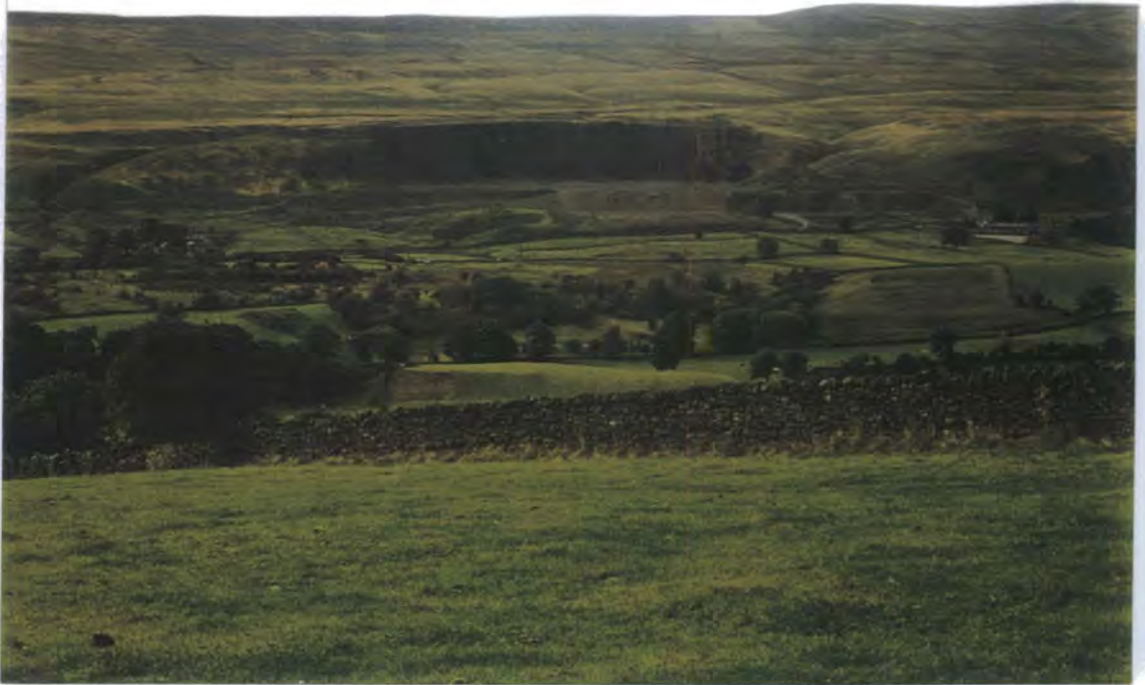
Figure 19.1 Quarry - Teesdale

Quarries and claypits present different problems, but both are apparently low risk. Only where the increasing importance of tourism could be a cause for reassessment would it be possible to justify works on quarries, perhaps in the form of controlled blasting as described earlier (Figure 19.1).
